PHASE I ENVIRONMENTAL SITE ASSESSMENT REPORT FOR

PROPOSED PROMENADE AT GLEN AVON
Multi-Tenant Commercial Property
North & South Sides of State Route 60
East of the Pyrite Street Exit, Jurupa Valley
(North) Riverside County, CA 92509

EAI Project Number: 80.ECOSYS1.19
August 27, 2019

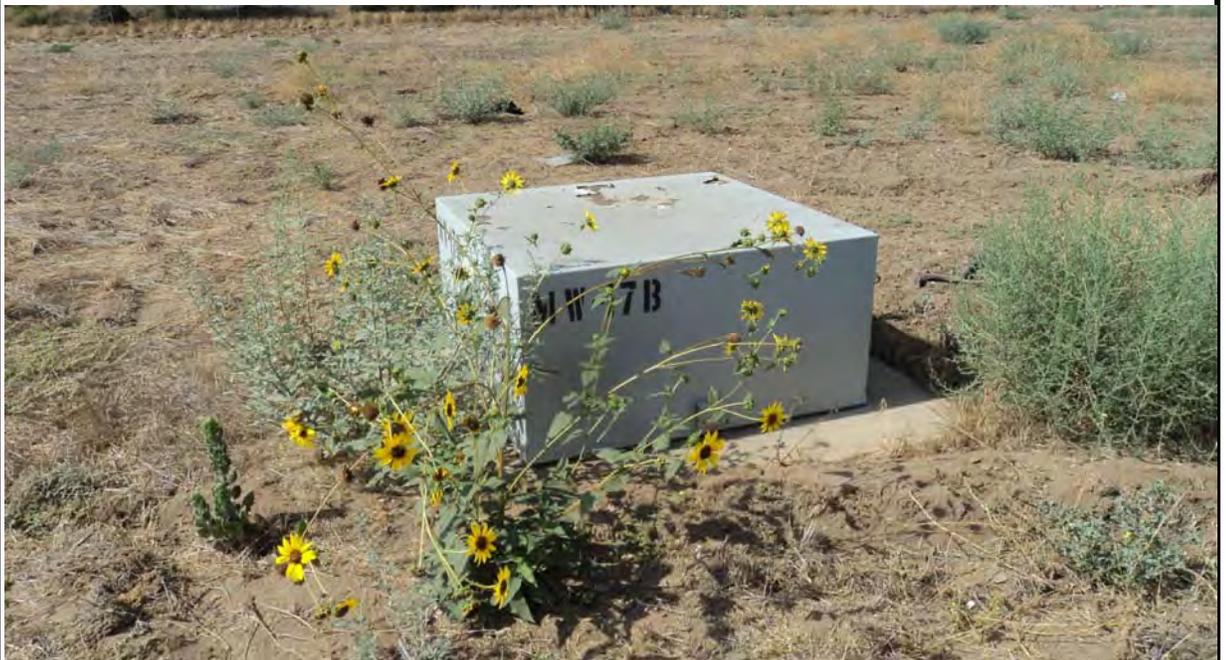
**Photograph
No. 2 of 20**

View of Monitoring Well box labeled MW-7B, located adjacent to Granite Hill Drive.

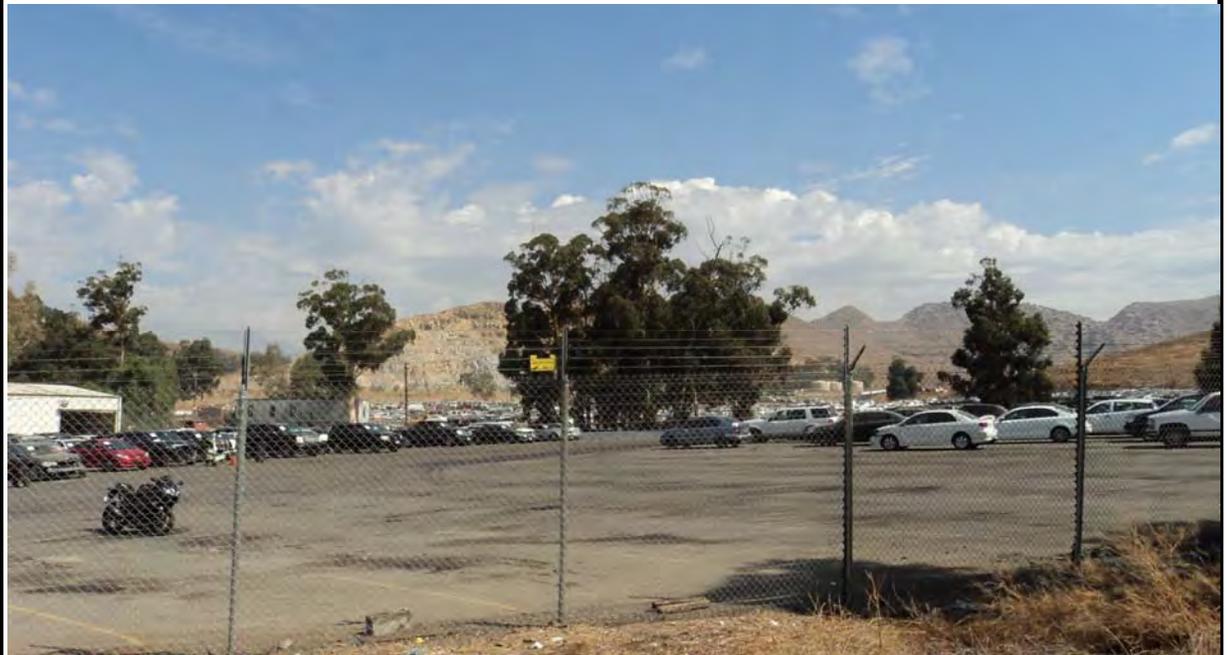
**Photograph
No. 6 of 20**

Looking north at adjacent property (auto salvage lot).

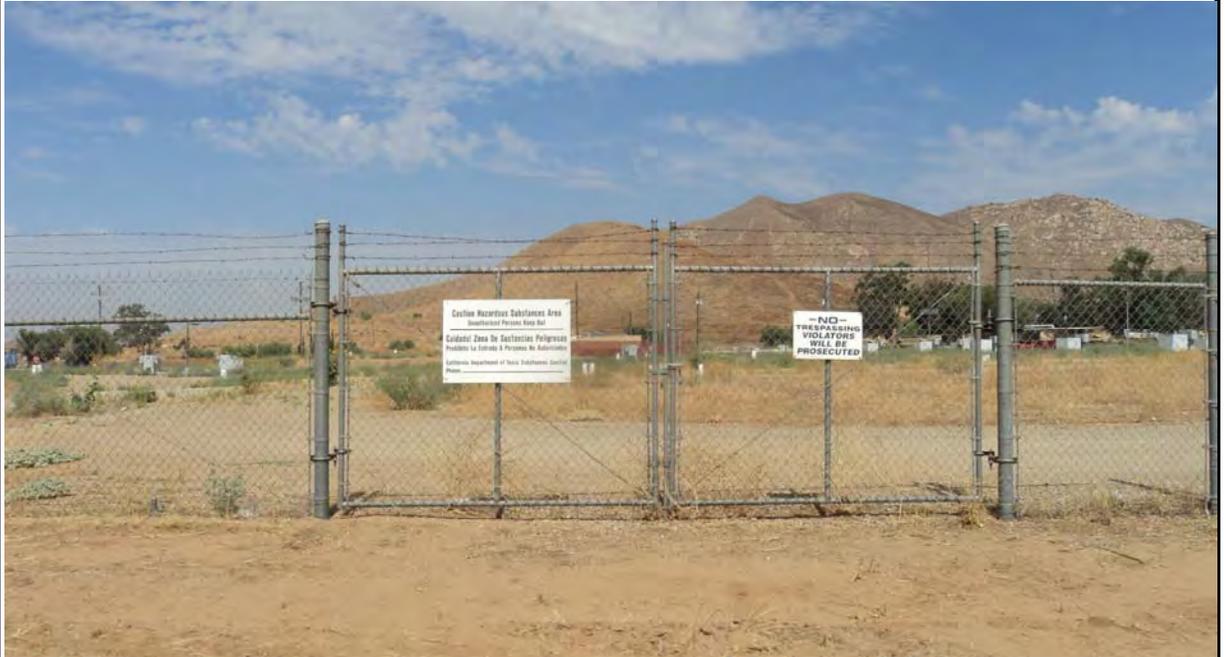
**Photograph
No. 7 of 20**

Looking west at remediation compound for Stringfellow Acid Pits site.

There were no observed potential adverse environmental conditions and no evidence of an ASTM REC or Historic REC (HREC) of the subject property based on the reconnaissance visit. The presence of groundwater monitoring wells on the subject property and the close proximity of the former Stringfellow Acid Pits (as evidenced by the adjacent remediation system compound) qualifies as an ASTM controlled REC (CREC) of the subject property.

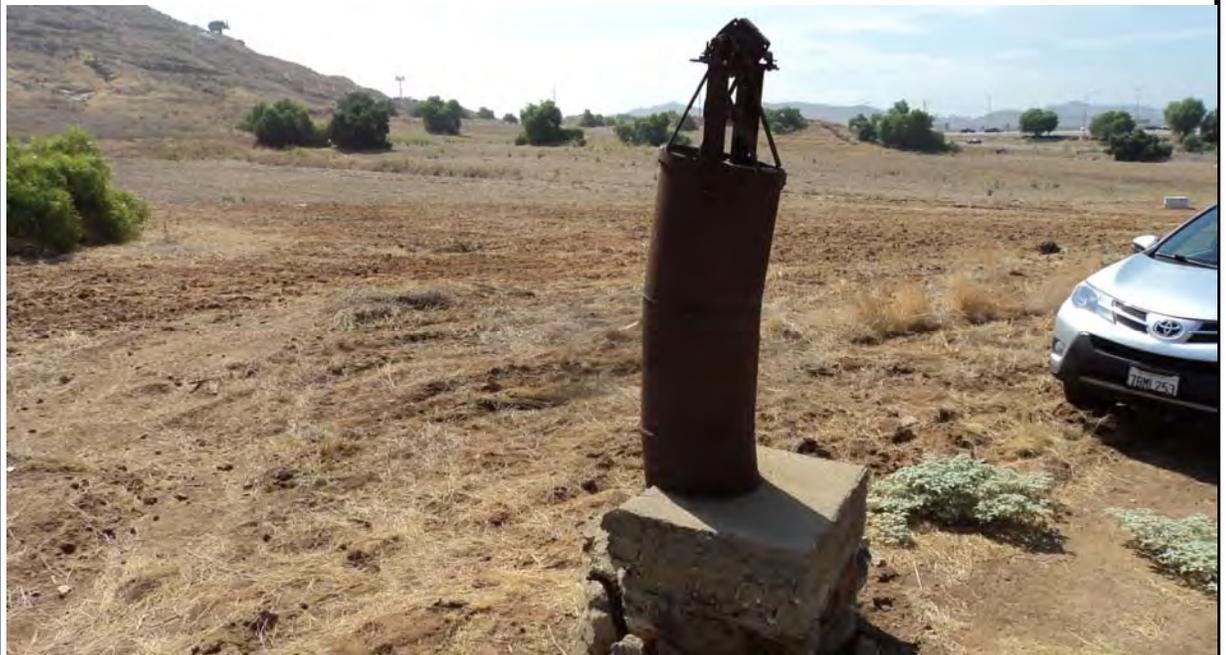
**Photograph
No. 8 of 20**

Looking south across northern portion of subject property at concrete-filled steel casing set in a concrete pad).

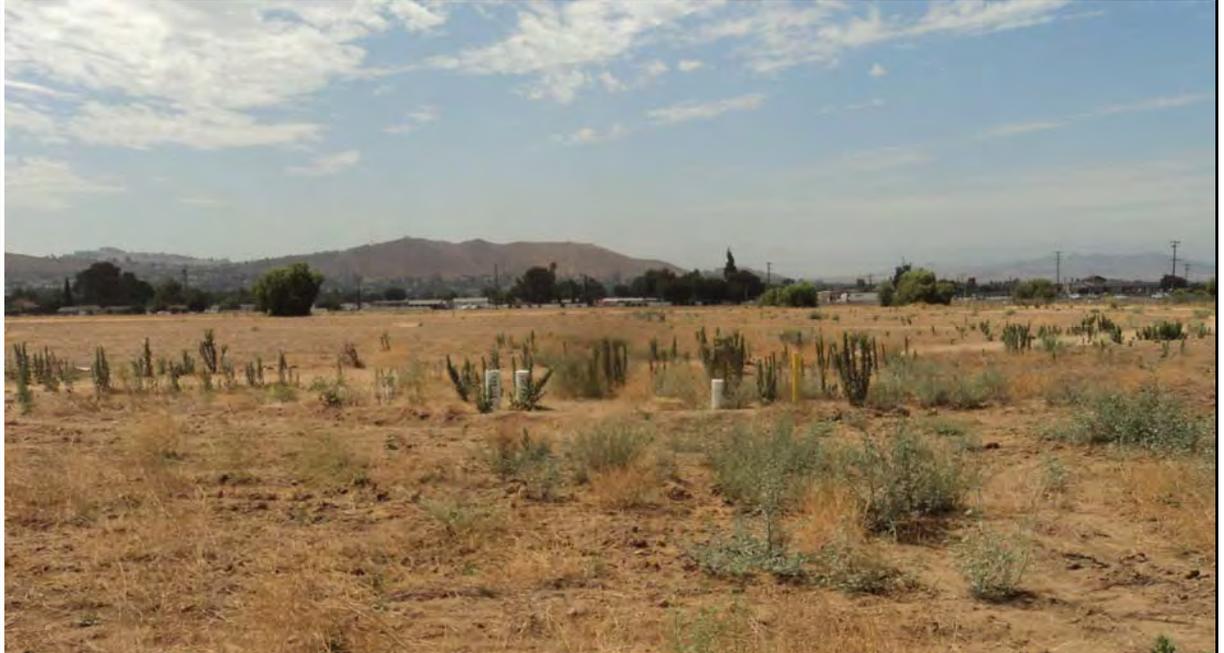
**Photograph
No. 13 of 20**

Looking south across southern portion subject property. Several monitoring wells are present in the foreground.

Observation	Description
On-site Pits, Ponds, or Lagoons:	None observed.
Stained Soil or Pavement:	None observed.
Stressed Vegetation:	None observed. However, some minor past brush fire evidence was observed in the northeast portion of the subject property.
Waste Streams and Waste Collection Areas:	None observed.
Solid Waste Disposal:	None observed or reported to be occurring (see other observations).
Potential Areas of Fill Placement:	None observed or reported to exist.
Wastewater:	No potential sources observed.
Storm water:	Storm water appears to drain off the subject property southward into main-made drainage channels. The subject property is not listed on the National Pollutant Discharge and Elimination System (NPDES) database in the EDR Report (Attachment 3). No indication of a discharge that would require a NPDES permit was observed.
Wells:	No water supply wells were observed. Surface completions for groundwater monitoring wells associated with the west-adjacent Stringfellow Acid Pits hazardous waste release site and its associated contaminant plume were observed on the subject property. Two were observed on the portion north of Highway 60 (labeled MW-16 and MW-17B) and seven sets (clusters) of monitoring well surface completions were observed on the portion of the subject property south of Highway 60 (labeled MW-18b, C115A2, FC-1, FC-3, and SV, the rest were unlabeled or illegible).

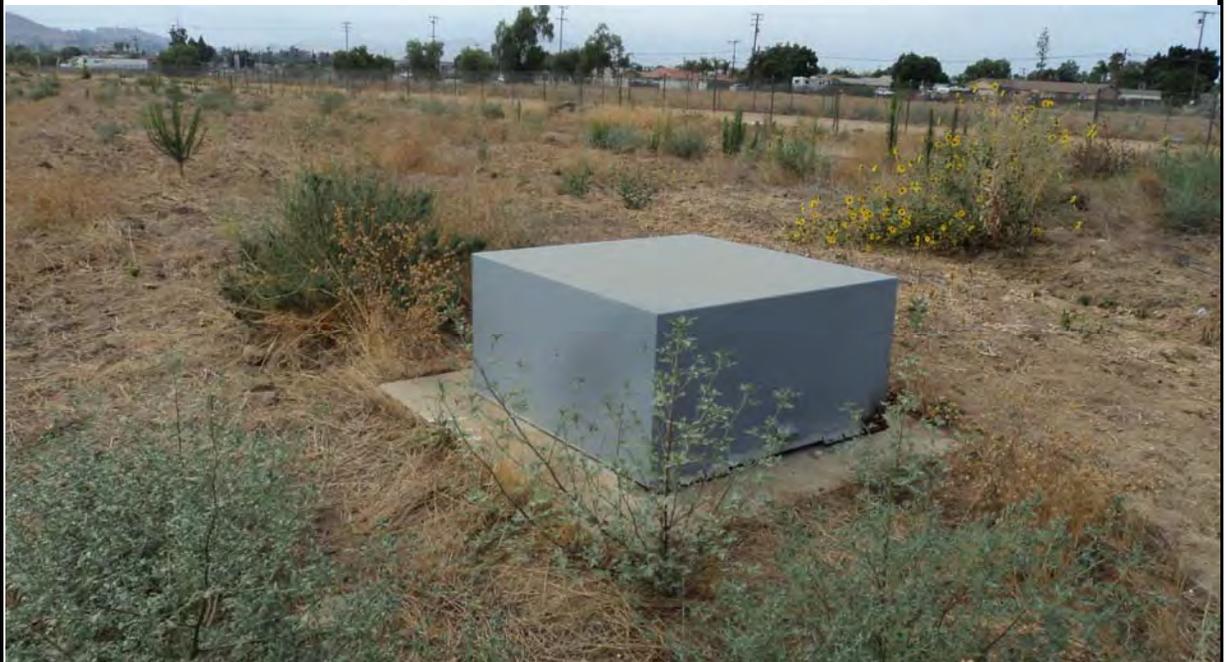
**Photograph
No. 14 of 20**

Looking southwest at monitoring well (unlabeled) in southern portion of subject property.

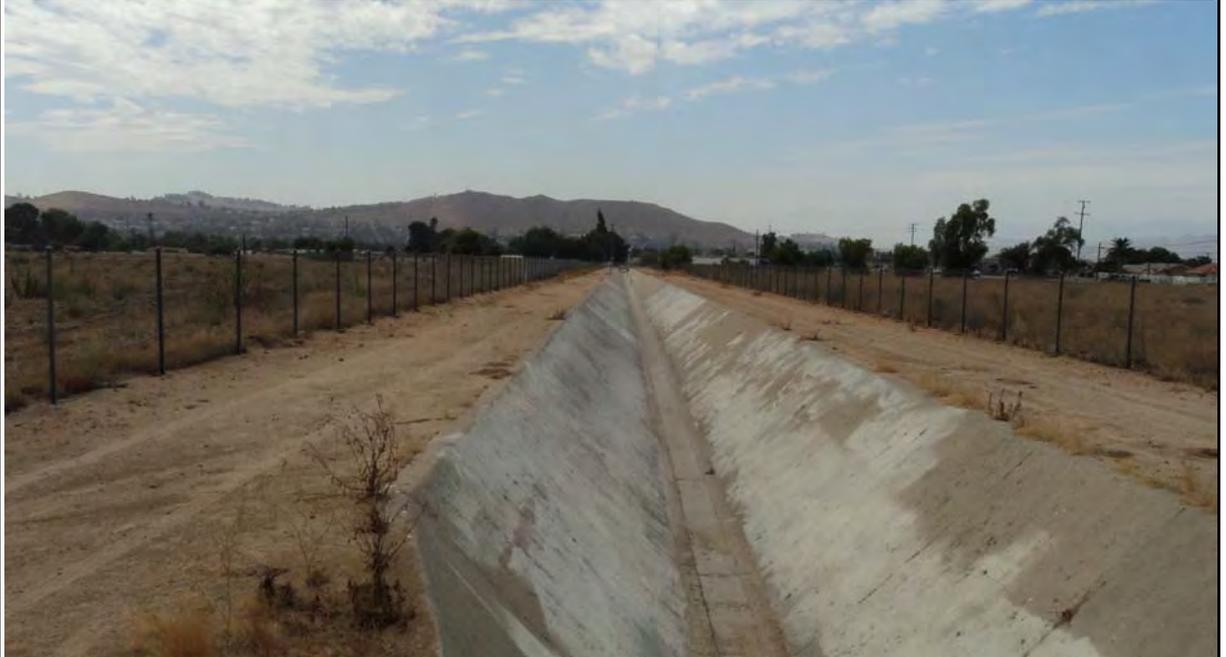
**Photograph
No. 15 of 20**

Looking south along concrete drainage channel in southern portion of subject property.

Existing USTs:	None observed.
Former USTs:	No evidence observed.
Other Underground Structures:	None observed, aside from existing storm ditches/channels.

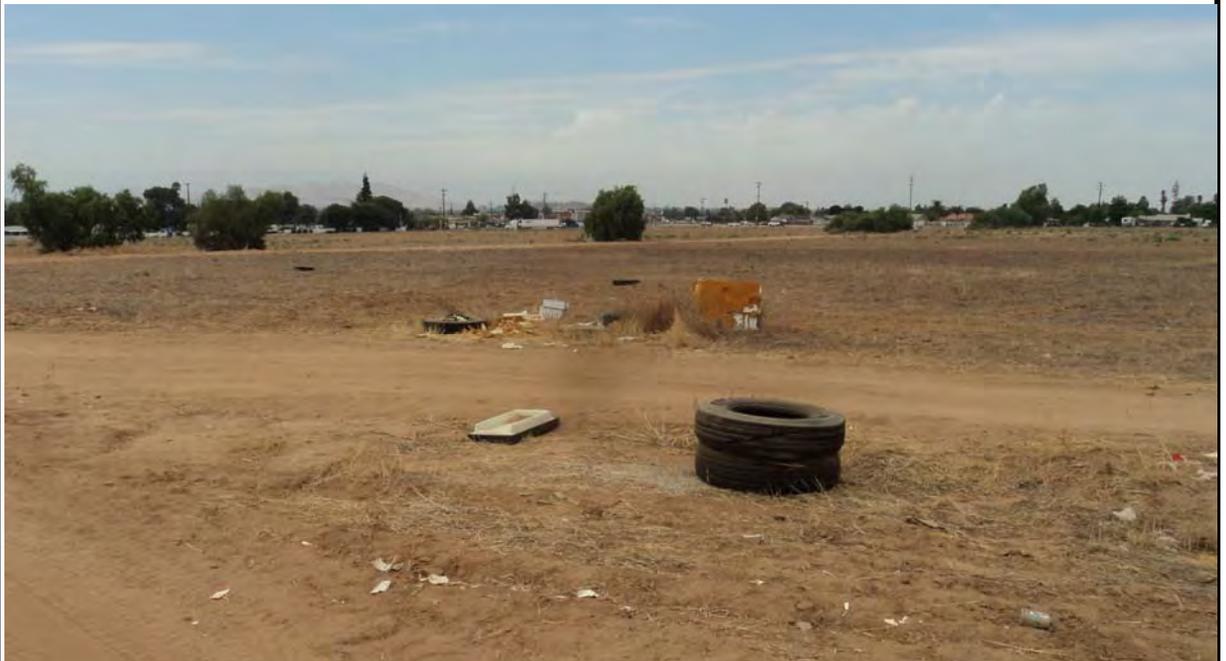
**Photograph
No. 16 of 20**

Looking southwest across southern portion of subject property. Numerous tires and trash were noted.

Other Exterior Observations:	Numerous waste tires have been dumped on the subject property, with the majority located on the portion to the south of State Highway 60. Several loads of broken concrete demo material, along with old household appliances and furniture were also observed. What appeared to be an abandoned homeless encampment, burnt-out van and burned debris was noted in the eastern area of the subject property, just south of Highway 60.
-------------------------------------	--

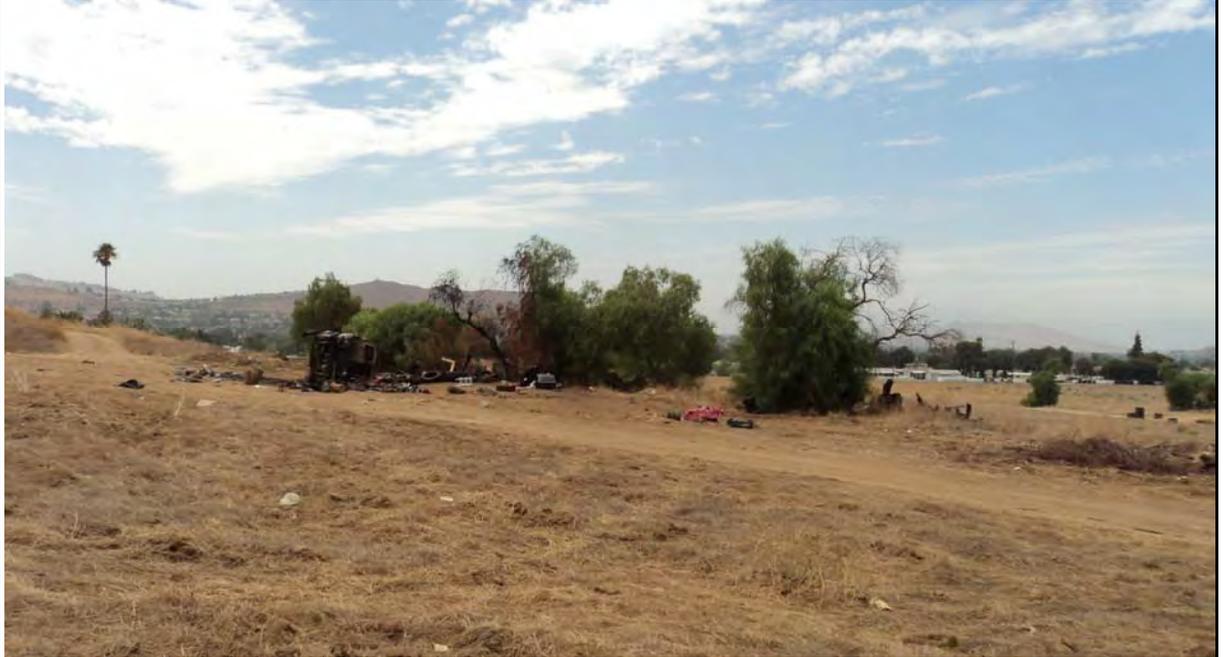
**Photograph
No. 17 of 20**

Looking south at burned van and debris in abandoned encampment in northeast corner of subject property.

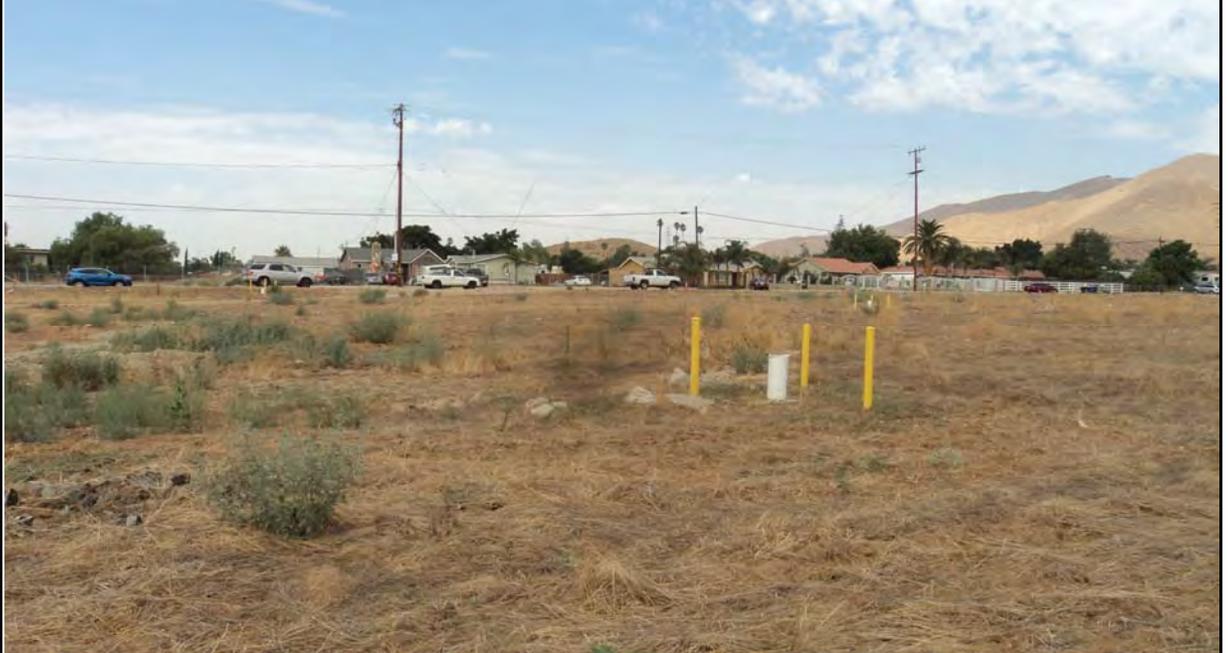
**Photograph
No. 19 of 20**

Looking west toward Pyrite Street in southern portion of subject property (note several monitoring wells in this area).

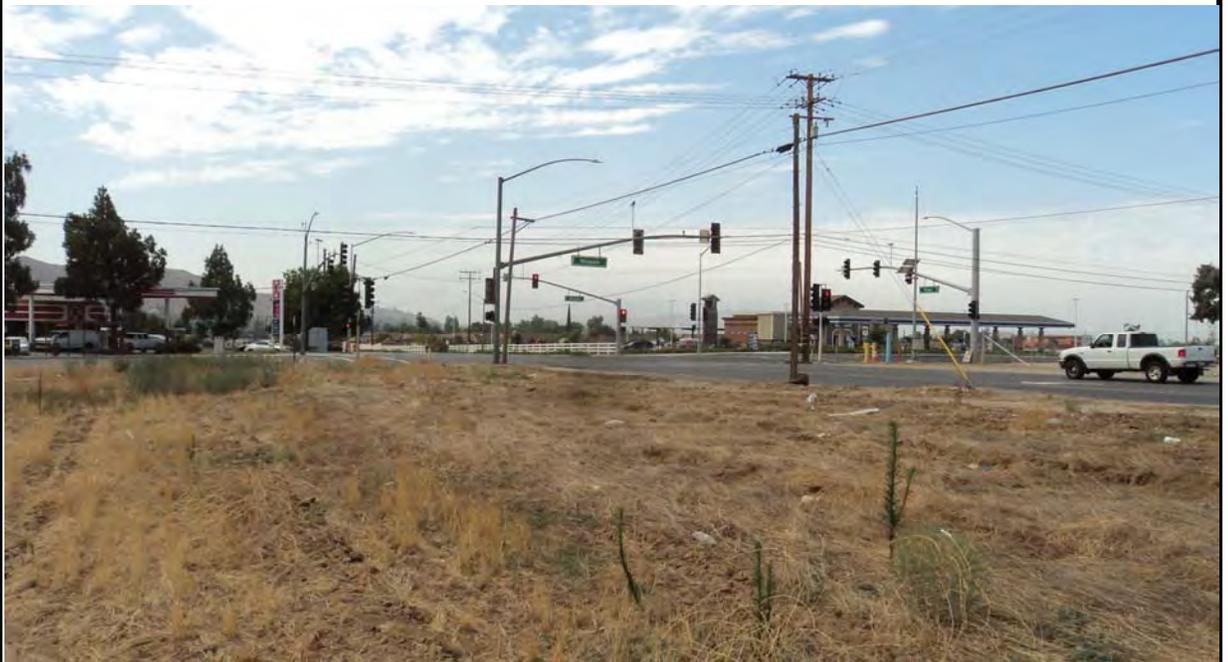
**Photograph
No. 20 of 20**

Looking southwest toward intersection of Pyrite Street and Misson Boulevard. Two gas stations were noted there.
